# Access Compliance Report Public Rights-of-Way (Curb Ramps)

Main Street: CORPORATE\_DR Cross Street: TERRACE\_RD Location: SE

ADA ID: RPRK211115161636 Ramp Type: Type 4 - Parallel Initial Pass/Fail: Fail Overall Compliance: No Severity Score: 32

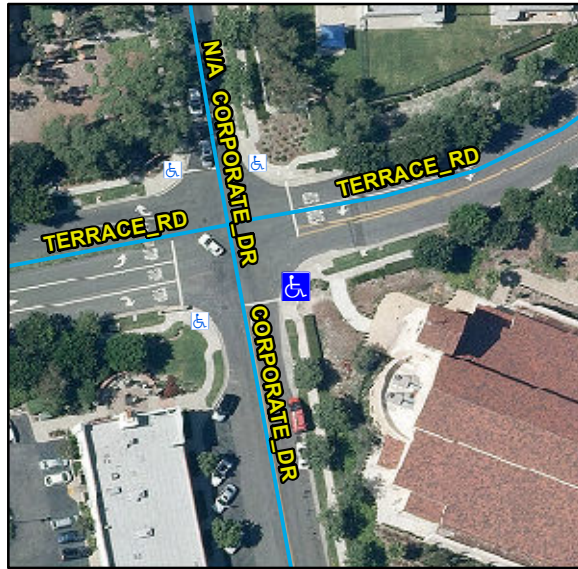
| Compliance | Description | Data | Compliance | Description | Data |
|---|---|---|---|---|---|
| No | Ramp Run Slope LT (%) | 12.3 | Yes | Ramp Run Slope RT (%) | 2 |
| Yes | Ramp Cross Slope LT (%) | 1.7 | No | Ramp Cross Slope RT (%) | 2.2 |

Remove & Replace Curb Ramp With Two New Directional Ramps or Equivalent.

R204.3, R304.3.2, R304.5.3, STD 1115

Total Cost: \$ 4000
