# Access Compliance Report Public Rights-of-Way (Curb Ramps)

Main Street: CORPORATE Cross Street: TERRACE\_RD Location: NE

ADA ID: RPRK211115162145 Ramp Type: Type 4 - Parallel Initial Pass/Fail: Fail Overall Compliance: No Severity Score: 16

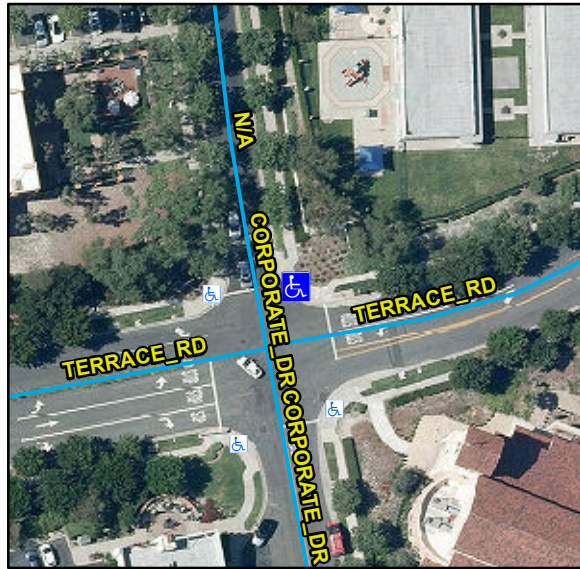
| Compliance | Description | Data | Compliance | Description | Data |
|---|---|---|---|---|---|
| Yes | Ramp Run Slope LT (%) | 2.9 | No | Ramp Run Slope RT (%) | 9.3 |
| No | Ramp Cross Slope LT (%) | 2.4 | Yes | Ramp Cross Slope RT (%) | 0.4 |

Remove & Replace Curb Ramp With Two New Directional Ramps or Equivalent.
