# Access Compliance Report Public Rights-of-Way (Curb Ramps)

Main Street: TERRACE\_RD Cross Street: CORPORATE Location: NW

ADA ID: RPRK211115162658 Ramp Type: Type 4 - Parallel Initial Pass/Fail: Fail Overall Compliance: No Severity Score: 15

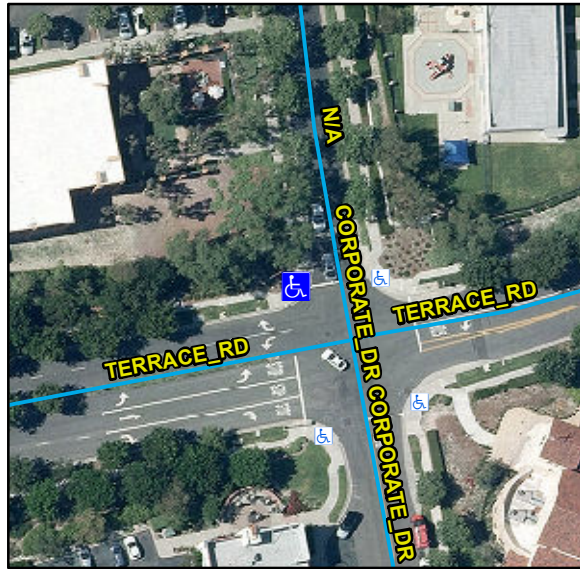
| Compliance | Description | Data | Compliance | Description | Data |
|---|---|---|---|---|---|
| No | Ramp Run Slope LT (%) | 9.6 | Yes | Ramp Run Slope RT (%) | 0.3 |

Remove & Replace Curb Ramp With Two New Directional Ramps or Equivalent.

R204.3, R304.3.2, STD 1115
