# Access Compliance Report Public Rights-of-Way (Curb Ramps)

Main Street: ANTONIO\_PKWY Cross Street: TERRACE\_RD Location: NE

ADA ID: RPRK211115164107 Ramp Type: Type 1 - Perpendicular Diagonal Initial Pass/Fail: Fail Overall Compliance: No Severity Score: 15

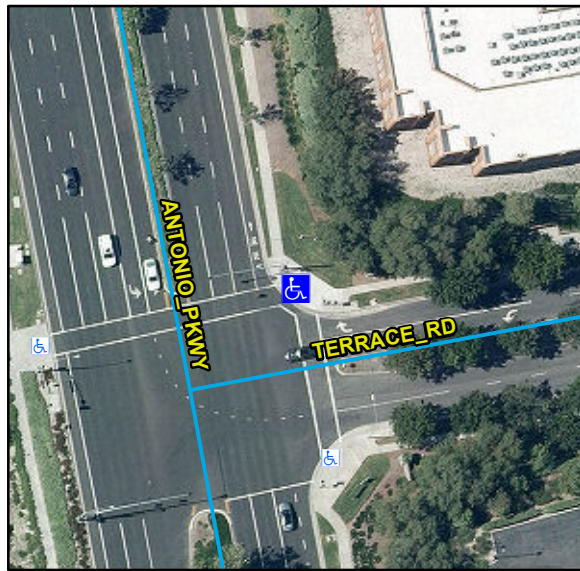
| Compliance | Description | Data | Compliance | Description | Data |
|---|---|---|---|---|---|
| No | Ramp Run Slope (%) | 10 | N/A | Flare Slope LT (%) | N/A |

**Remove & Replace Curb Ramp With Two New Directional Ramps or Equivalent.**

**R304.2.2, R204.3, STD 1115**
