# Access Compliance Report Public Rights-of-Way (Curb Ramps)

Main Street: TERRACE\_RD Cross Street: ANTONIO\_PKWY Location: SE

ADA ID: RPRK211115164834 Ramp Type: Type 1 - Perpendicular Diagonal Initial Pass/Fail: Pass Overall Compliance: No Severity Score: 16

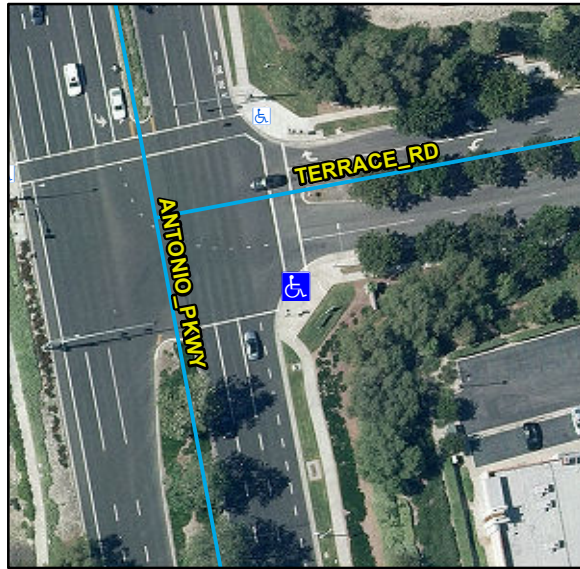
| Compliance | Description | Data | Compliance | Description | Data |
|---|---|---|---|---|---|
| No | Landing Run Slope (%) | 3.2 | N/A | Flare Traversable RT | No |
| No | Landing Cross Slope (%) | 4 | No | DWS Provided | No |
| Yes | Gutter Ponding | No | No | Curb Slope | 7.7 |
| No | Gutter Run Slope (%) | 6 | | Road Cross Slope (%) | 0.6 |

Remove & Replace Curb Ramp With Two New Directional Ramps or Equivalent. Remove & Replace Gutter.
