# Access Compliance Report Public Rights-of-Way (Curb Ramps)

Main Street: CORPORATE\_DR Cross Street: ANTONIO\_PKWY Location: SE

ADA ID: RPRK211115170215 Ramp Type: Type 1 - Perpendicular Diagonal Initial Pass/Fail: Fail Overall Compliance: No Severity Score: 20

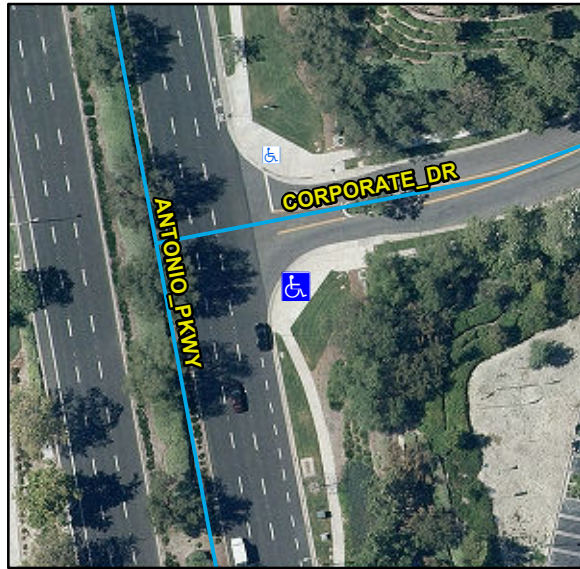
| Compliance | Description | Data | Compliance | Description | Data |
|---|---|---|---|---|---|
| No | Ramp Width (in) | 47 | | | N/A |
| No | Ramp Run Slope (%) | 10.5 | N/A | Flare Slope LT (%) | N/A |
| No | Ramp Cross Slope (%) | 2.1 | N/A | Flare Traversable LT | N/A |

Remove & Replace Curb Ramp With Two New Directional Ramps or Equivalent.
