# Access Compliance Report Public Rights-of-Way (Curb Ramps)

Main Street: AVENDALE\_BLVD Cross Street: ANTONIO\_PKWY Location: NW

ADA ID: RPRK211115171256 Ramp Type: Type 1 - Perpendicular Diagonal Initial Pass/Fail: Pass Overall Compliance: No Severity Score: 16

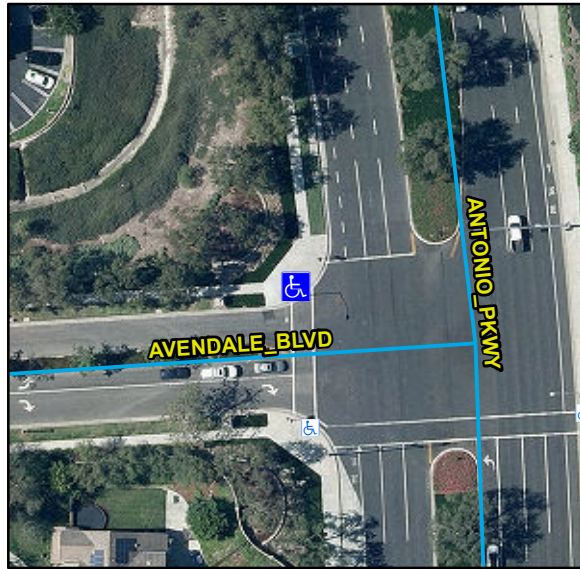
| Compliance | Description | Data | Compliance | Description | Data |
|---|---|---|---|---|---|
| No | Landing Cross Slope (%) | 4.3 | No | DWS Provided | No |
| Yes | Gutter Ponding | No | No | Curb Slope | 7 |
| No | Gutter Run Slope (%) | 8 | | Road Cross Slope (%) | 4.4 |

Remove & Replace Curb Ramp With Two New Directional Ramps or Equivalent. Remove & Replace Gutter.
