# Access Compliance Report Public Rights-of-Way (Curb Ramps)

Main Street: ANTONIO\_PKWY Cross Street: AVENDALE\_BLVD Location: SW

ADA ID: RPRK211115172449 Ramp Type: Type 1 - Perpendicular Diagonal Initial Pass/Fail: Fail Overall Compliance: No Severity Score: 15

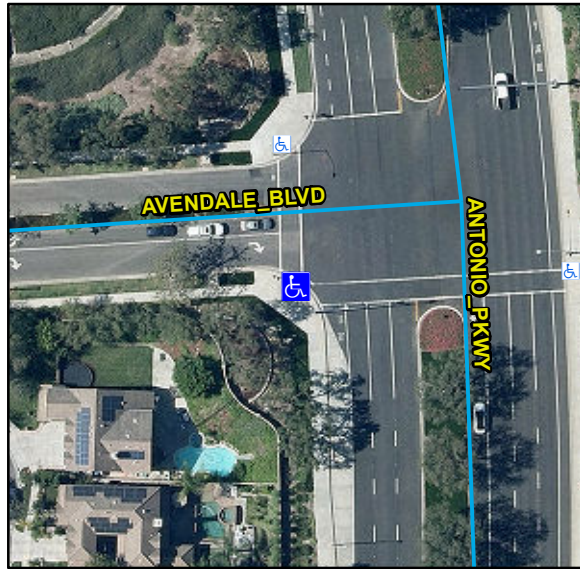
| Compliance | Description | Data | Compliance | Description | Data |
|---|---|---|---|---|---|
| No | Ramp Cross Slope (%) | 5.3 | N/A | Flare Traversable LT | N/A |

Remove & Replace Curb Ramp With Two New Directional Ramps or Equivalent.
