# Access Compliance Report Public Rights-of-Way (Curb Ramps)

Main Street: STATION\_WAY Cross Street: ANTONIO\_PKWY Location: SE

ADA ID: RPRK211116113224 Ramp Type: Type 1 - Perpendicular Diagonal Initial Pass/Fail: Pass Overall Compliance: No Severity Score: 20

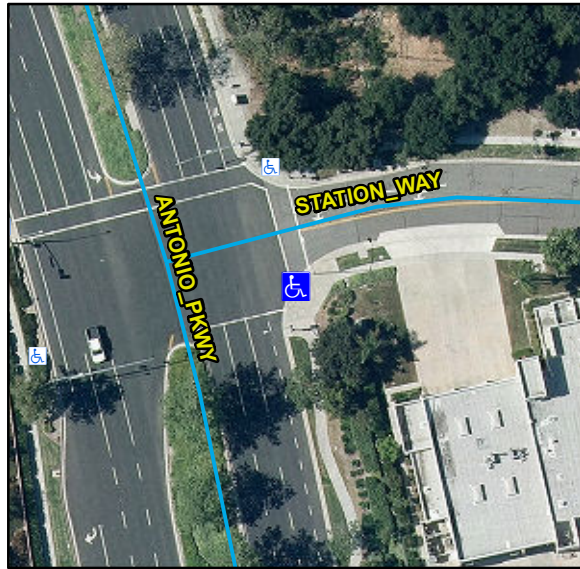
| Compliance | Description | Data | Compliance | Description | Data |
|---|---|---|---|---|---|
| No | Landing Run Slope (%) | 3.2 | N/A | Flare Traversable RT | Yes |
| Yes | Landing Cross Slope (%) | 1.5 | No | DWS Provided | No |
| No | Gutter Run Slope (%) | 11.2 | | Road Cross Slope (%) | 0.5 |
| No | Gutter Cross Slope (%) | 2.3 | | | |

Remove & Replace Curb Ramp With Two New Directional Ramps or Equivalent. Remove & Replace Gutter.
