# Access Compliance Report Public Rights-of-Way (Curb Ramps)

Main Street: ANTONIO\_PKWY Cross Street: STATION\_WAY Location: NE

ADA ID: RPRK211116113756 Ramp Type: Type 1 - Perpendicular Diagonal Initial Pass/Fail: Pass Overall Compliance: No Severity Score: 16

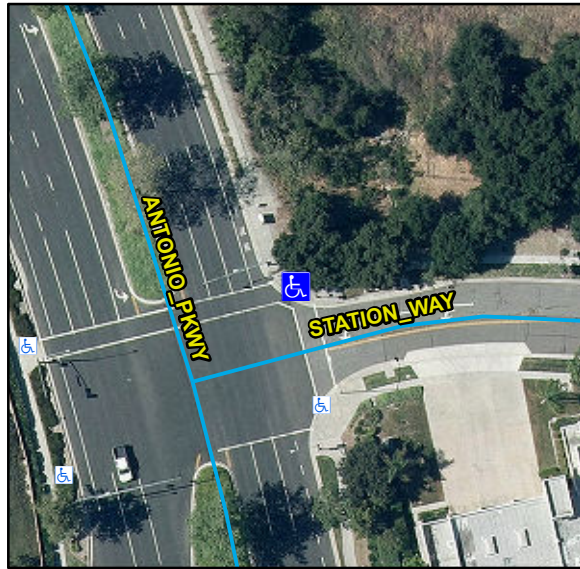
| Compliance | Description | Data | Compliance | Description | Data |
|---|---|---|---|---|---|
| No | Landing Run Slope (%) | 2.2 | N/A | Flare Traversable RT | No |
| No | Landing Cross Slope (%) | 2.1 | No | DWS Provided | No |
| No | Gutter Run Slope (%) | 6.1 | | Road Cross Slope (%) | 1.4 |

Remove & Replace Curb Ramp With Two New Directional Ramps or Equivalent. Remove & Replace Gutter.
