# Access Compliance Report Public Rights-of-Way (Curb Ramps)

Main Street: ANTONIO\_PKWY Cross Street: ANTONIO\_PKWY Location: NW

ADA ID: RPRK211116114322 Ramp Type: Type 1 - Perpendicular Initial Pass/Fail: Pass Overall Compliance: No Severity Score: 16

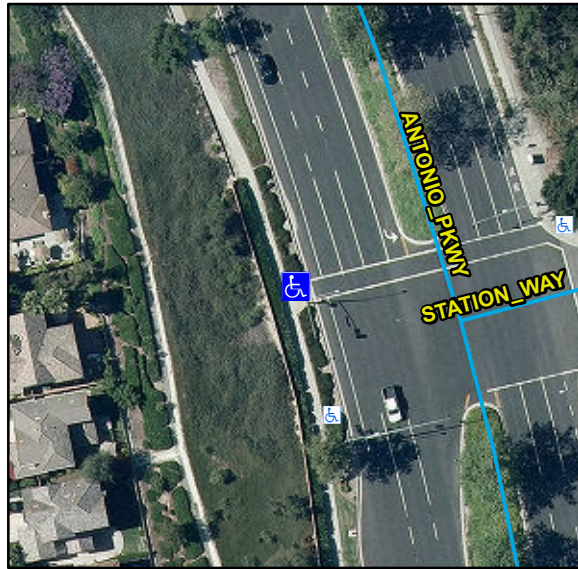
## Field Measurements/Component Compliance

| Compliance | Description | Data | Compliance | Description | Data |
|---|---|---|---|---|---|
| No | Landing Cross Slope (%) | 2.7 | No | DWS Provided | No |
| No | Gutter Run Slope (%) | 10.6 | | Road Cross Slope (%) | N/A |
| No | Gutter Cross Slope (%) | 2.9 | | | |

Remove & Replace Entire Ramp. Remove & Replace Gutter. Utility Present.

R304.2.2, R304.5.3, R305, R304.5.4, STD 1115
