# Access Compliance Report Public Rights-of-Way (Curb Ramps)

| Main Street: ANTONIO_PKWY | | Cross Street: ANTONIO_PKWY | | Location: | NW |
| ADA ID: RPRK211116115848 | Ramp Type:Type 1 - Perpendicular | Initial Pass/Fail: Pass | Overall Compliance: No | Severity Score: | 17 |

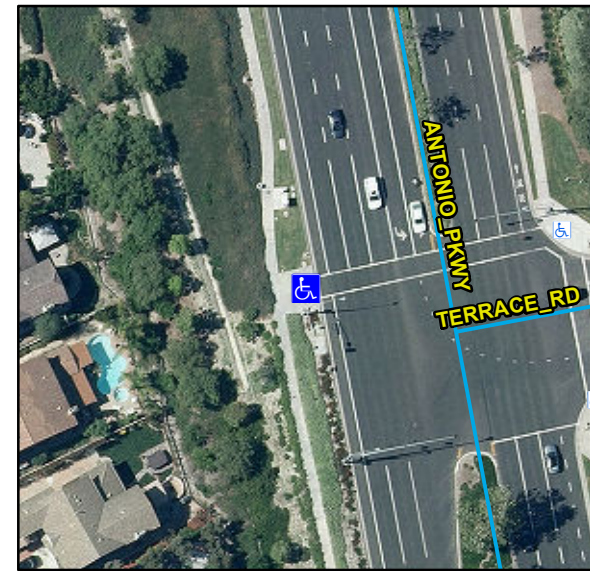
| Compliance | Description | Data | Compliance | Description | Data |
|---|---|---|---|---|---|
| No | Landing Cross Slope (%) | 2.4 | No | DWS Provided | No |
| Yes | Gutter Ponding | No | No | Curb Slope | 7 |
| No | Gutter Run Slope (%) | 8.9 | | Road Cross Slope (%) | N/A |

**Remove & Replace Entire Ramp. Remove & Replace Gutter.**

**R304.2.2, R304.5.3, R305, R304.5.4, STD 1115**

Total Cost: \$ 3332

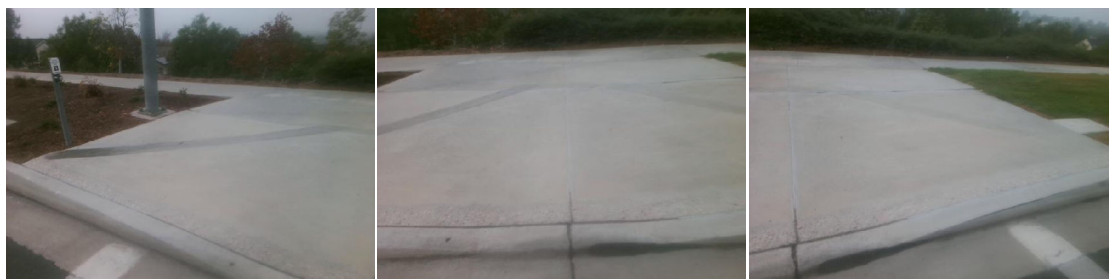
| Compliance | Description | Data | Compliance | Description | Data |
|---|---|---|---|---|---|
| N/A | Ramp Length (in) | 125 | N/A | Flare Type LT | |
| Yes | Ramp Width (in) | 48 | | | Sloped |
| Yes | Ramp Run Slope (%) | 3.9 | Yes | Flare Slope LT (%) | 3.9 |
| Yes | Ramp Cross Slope (%) | 1.7 | N/A | Flare Traversable LT | Yes |
| N/A | Landing Length (in) | 83 | | | Sloped |
| Yes | Landing Width (in) | 48 | Yes | Flare Slope RT (%) | 8 |
| Yes | Landing Run Slope (%) | 1.4 | N/A | Flare Traversable RT | Yes |
