# Access Compliance Report Public Rights-of-Way (Curb Ramps)

Main Street: ANTONIO\_PKWY Cross Street: AVENDALE\_BLVD Location: SE

ADA ID: RPRK211116120943 Ramp Type: Type 4 - Parallel Initial Pass/Fail: Pass Overall Compliance: No Severity Score: 20

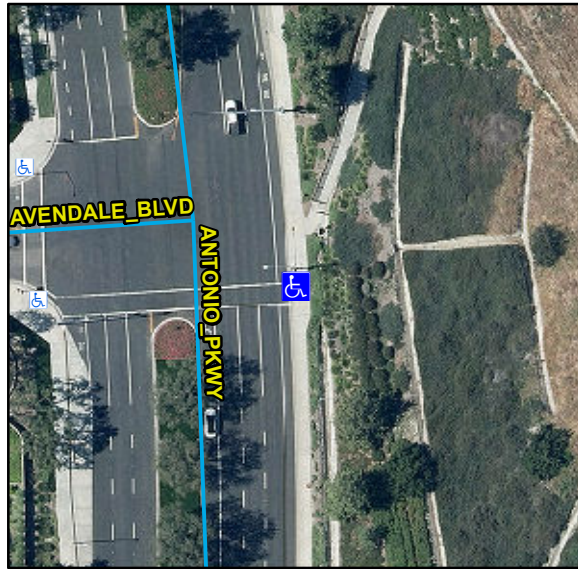
| Compliance | Description | Data | Compliance | Description | Data |
|---|---|---|---|---|---|
| N/A | Landing Present | No | No | DWS Provided | No |
| No | Landing Width (in) | N/A | N/A | DWS Length (in) | N/A |
| No | Landing Run Slope (%) | N/A | N/A | DWS Full Width | N/A |
| No | Landing Cross Slope (%) | N/A | | DWS Offset Type | N/A |
| Yes | Gutter Ponding | No | No | Curb Slope | 9.8 |
| Yes | Gutter Cross Slope (%) | 1.9 | No | Perpendicular Joint Present | No |

Remove & Replace Entire Ramp.

R304.2.2, R204.3, R304.2.1, R304.2.2-Perp,  
R304.3.2-Para, R304.5.3, R305, STD 1115

Total Cost: \$ 2000
