# Access Compliance Report Public Rights-of-Way (Curb Ramps)

Main Street: CORPORATE\_DR Cross Street: CORPORATE\_DR Location: S

ADA ID: RPRK211116121559 Ramp Type: Type 4 - Parallel Initial Pass/Fail: Fail Overall Compliance: No Severity Score: 15

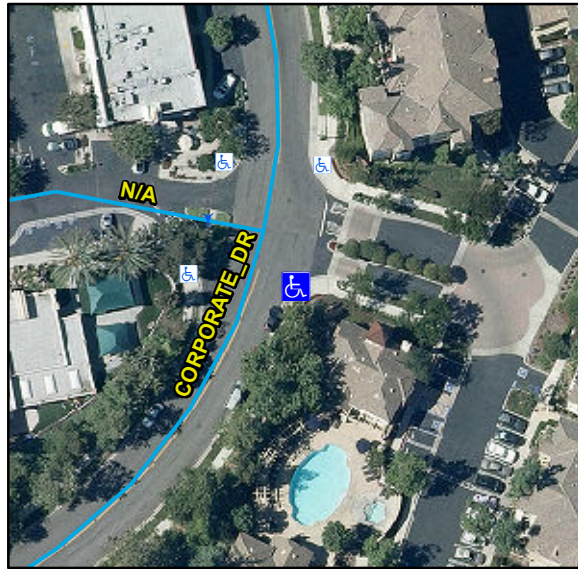
| Compliance | Description | Data | Compliance | Description | Data |
|---|---|---|---|---|---|
| No | Ramp Run Slope LT (%) | 9.9 | Yes | Ramp Run Slope RT (%) | 1 |

**Remove & Replace Curb Ramp With Two New Directional Ramps or Equivalent.**

**R204.3, R304.3.2, STD 1115**

Total Cost: \$ 4000
