# Access Compliance Report Public Rights-of-Way (Curb Ramps)

Main Street: CORPORATE\_DR Cross Street: CORPORATE\_DR Location: E

ADA ID: RPRK211116122407 Ramp Type: Type 4 - Parallel Initial Pass/Fail: Fail Overall Compliance: No Severity Score: 2

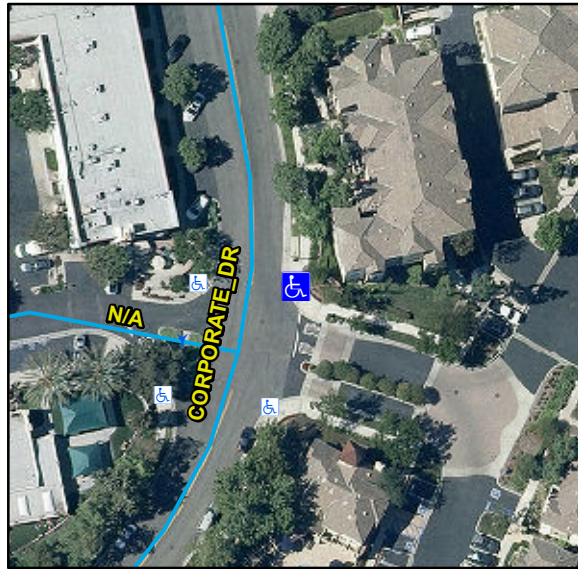
| Compliance | Description | Data | Compliance | Description | Data |
|---|---|---|---|---|---|
| No | Ramp Cross Slope LT (%) | 2.6 | No | Ramp Cross Slope RT (%) | 2.3 |

Remove & Replace Curb Ramp With Two New Directional Ramps or Equivalent.

R204.3, R304.5.3, STD 1115

Total Cost: \$ 4000
