# Access Compliance Report Public Rights-of-Way (Curb Ramps)

| Main Street: CORPORATE_DR | | Cross Street: CORPORATE_DR | | Location: | NW |
| ADA ID: RPRK211116122612 | Ramp Type: Type 4 - Parallel | Initial Pass/Fail: Pass | Overall Compliance: No | Severity Score: | 25 |

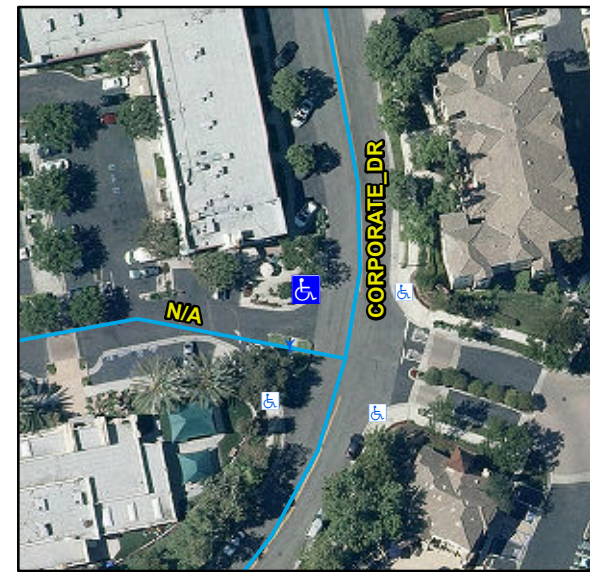
**R304.2.1, R304.2.2-Perp, R304.3.2-Para, R304.5.3, R305, R304.5.4, STD 1115**

| Compliance | Description | Data | Compliance | Description | Data |
|---|---|---|---|---|---|
| N/A | Landing Present | No | No | DWS Provided | No |
| No | Landing Width (in) | N/A | N/A | DWS Length (in) | N/A |
| No | Gutter Run Slope (%) | 5.7 | | Road Cross Slope (%) | 1.9 |

**Remove & Replace Curb Ramp With Two New Directional Ramps or Equivalent. Remove & Replace Gutter.**
