# Access Compliance Report Public Rights-of-Way (Curb Ramps)

Main Street: CORPORATE\_DR Cross Street: N/A Location: W

ADA ID: RPRK211116123011 Ramp Type: Type 4 - Parallel Initial Pass/Fail: Pass Overall Compliance: No Severity Score: 0

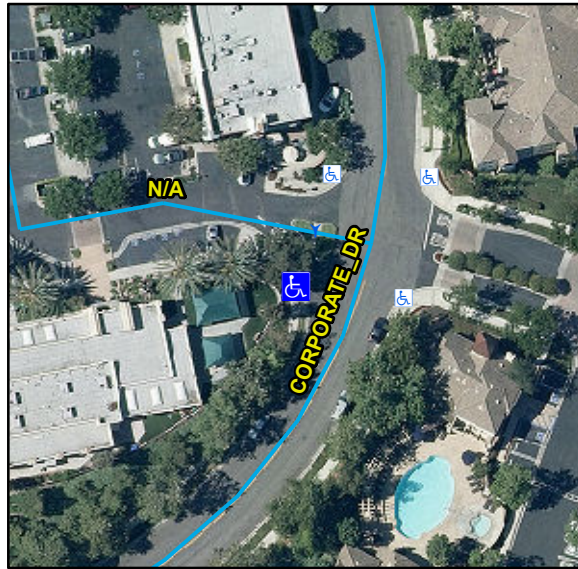
| Compliance | Description | Data | Compliance | Description | Data |
|---|---|---|---|---|---|
| No | Landing Cross Slope (%) | 2.3 | | DWS Offset Type | Single |
| No | Gutter Cross Slope (%) | 2.3 | Yes | Perpendicular Joint Present | Yes |

Remove & Replace Landing. Remove & Replace Gutter.

R304.5.3, STD 1115
