# Access Compliance Report Public Rights-of-Way (Curb Ramps)

Main Street: O\_NEILL\_DR Cross Street: ANTONIO\_PKWY Location: NW

ADA ID: RPRK211116124541 Ramp Type: Type 1 - Perpendicular Diagonal Initial Pass/Fail: Pass Overall Compliance: No Severity Score: 12

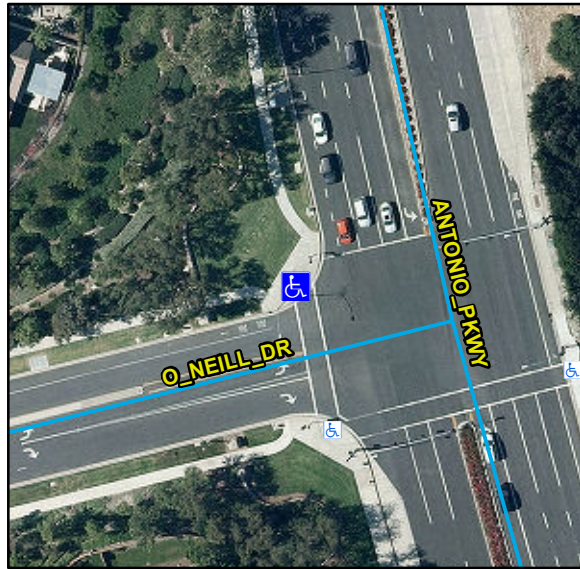
| Compliance | Description | Data | Compliance | Description | Data |
|---|---|---|---|---|---|
| No | Ramp Cross Slope (%) | 2.4 | N/A | Flare Traversable LT | Yes |
| No | Landing Cross Slope (%) | 2.8 | No | DWS Provided | No |
| Yes | Gutter Ponding | No | No | Curb Slope | 7.2 |

Remove & Replace Curb Ramp With Two New Directional Ramps or Equivalent.

R304.2.2, R304.5.3, R305, STD 1115
