# Access Compliance Report Public Rights-of-Way (Curb Ramps)

Main Street: ANTONIO\_PKWY Cross Street: O\_NEILL\_DR Location: SW

ADA ID: RPRK211116125149 Ramp Type: Type 1 - Perpendicular Diagonal Initial Pass/Fail: Fail Overall Compliance: No Severity Score: 2

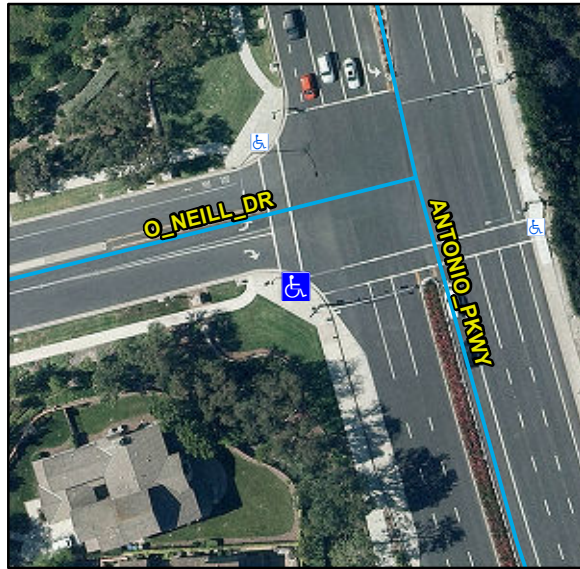
| Compliance | Description | Data | Compliance | Description | Data |
|---|---|---|---|---|---|
| No | Ramp Cross Slope (%) | 2.7 | N/A | Flare Traversable LT | N/A |

**Remove & Replace Curb Ramp With Two New Directional Ramps or Equivalent.**

**R204.3, R304.5.3, STD 1115**
