# Access Compliance Report Public Rights-of-Way (Curb Ramps)

| Main Street: ANTONIO_PKWY | | Cross Street: O_NEILL_DR | | Location: | SE |
| ADA ID: RPRK211116125447 | Ramp Type: Type 4 - Parallel | Initial Pass/Fail: Fail | Overall Compliance: No | Severity Score: | 15 |

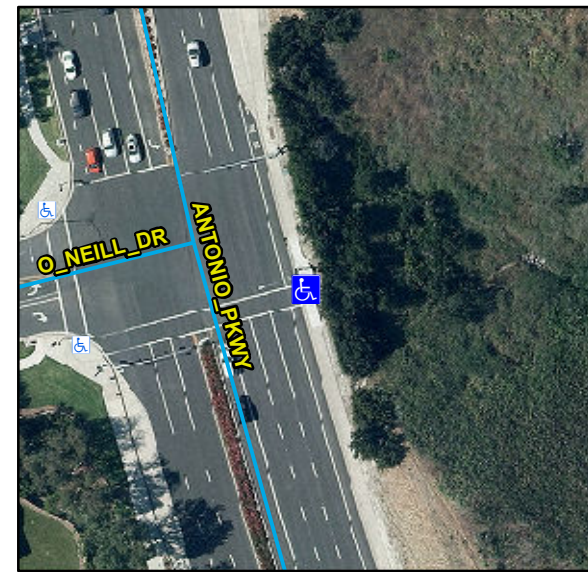
| Compliance | Description | Data | Compliance | Description | Data |
|---|---|---|---|---|---|
| No | Ramp Run Slope LT (%) | 8.8 | Yes | Ramp Run Slope RT (%) | 7.3 |

Remove & Replace Entire Ramp.

R304.3.2, STD 1115
