# Access Compliance Report Public Rights-of-Way (Curb Ramps)

Main Street: ANTONIO\_PKWY Cross Street: SENDERO\_WAY Location: NE

ADA ID: RPRK211116132311 Ramp Type: Type 1 - Perpendicular Diagonal Initial Pass/Fail: Pass Overall Compliance: No Severity Score: 16

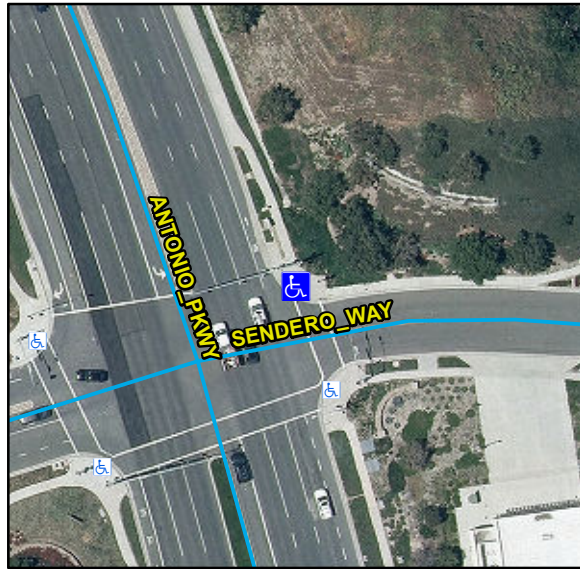
| Compliance | Description | Data | Compliance | Description | Data |
|---|---|---|---|---|---|
| Yes | Ramp Run Slope (%) | 7.6 | No | Flare Slope LT (%) | 11 |
| No | Landing Cross Slope (%) | 6.6 | Yes | DWS Provided | Yes |
| No | Gutter Run Slope (%) | 9.3 | | Road Cross Slope (%) | 0.7 |

**Remove & Replace Curb Ramp With Two New Directional Ramps or Equivalent. Remove & Replace Gutter.**

**R304.2.1, R304.5.3, R304.2.3, R304.5.4, STD 1115**
