# Access Compliance Report Public Rights-of-Way (Curb Ramps)

Main Street: SENDERO WAY Cross Street: ANTONIO PKWY Location: SE

ADA ID: RPRK211116132900 Ramp Type: Type 1 - Perpendicular Diagonal Initial Pass/Fail: Fail Overall Compliance: No Severity Score: 2

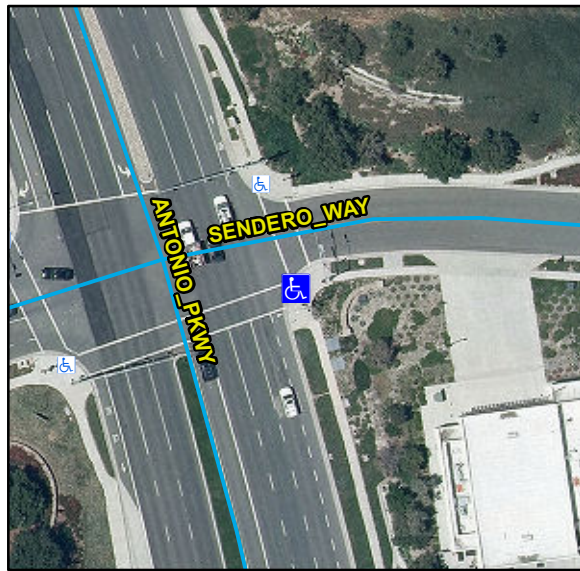
| Compliance | Description | Data | Compliance | Description | Data |
|---|---|---|---|---|---|
| No | Ramp Cross Slope (%) | 3.4 | N/A | Flare Traversable LT | N/A |

Remove & Replace Curb Ramp With Two New Directional Ramps or Equivalent.

R304.5.3, STD 1115
