# Access Compliance Report Public Rights-of-Way (Curb Ramps)

Main Street: ANTONIO\_PKWY Cross Street: SENDERO\_WAY Location: SW

ADA ID: RPRK211116133438 Ramp Type: Type 1 - Perpendicular Diagonal Initial Pass/Fail: Pass Overall Compliance: No Severity Score: 0

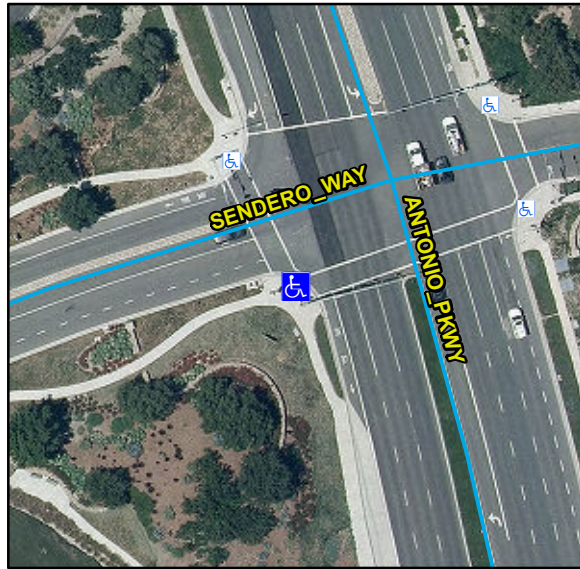
| Compliance | Description | Data | Compliance | Description | Data |
|---|---|---|---|---|---|
| No | Landing Cross Slope (%) | 3.2 | Yes | DWS Provided | Yes |

Remove & Replace Landing.
