# Access Compliance Report Public Rights-of-Way (Curb Ramps)

Main Street: SENDERO\_WAY Cross Street: ANTONIO\_PKWY Location: NW

ADA ID: RPRK211116133838 Ramp Type: Type 1 - Perpendicular Diagonal Initial Pass/Fail: Fail Overall Compliance: No Severity Score: 45

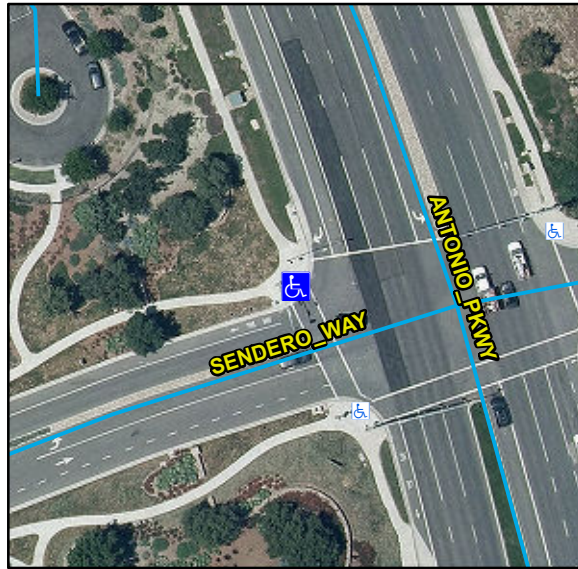
| Compliance | Description | Data | Compliance | Description | Data |
|---|---|---|---|---|---|
| No | Ramp Run Slope (%) | 8.8 | N/A | Flare Slope LT (%) | N/A |
| No | Ramp Cross Slope (%) | 9.3 | N/A | Flare Traversable LT | N/A |

Remove & Replace Curb Ramp With Two New Directional Ramps or Equivalent.

R304.2.2, R304.5.3, STD 1115
