# Access Compliance Report Public Rights-of-Way (Curb Ramps)

| Main Street: VIVIDO_ST | | Cross Street: FUTURO_ST | | Location: | S |
| ADA ID: RPRK211116134736 | Ramp Type: Type 4 - Parallel | Initial Pass/Fail: Fail | Overall Compliance: No | Severity Score: | 15 |

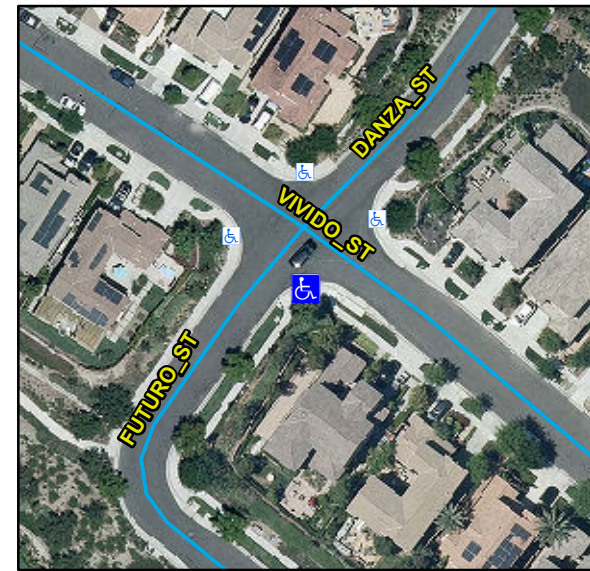
| Compliance | Description | Data | Compliance | Description | Data |
|---|---|---|---|---|---|
| No | Ramp Run Slope LT (%) | 11.6 | Yes | Ramp Run Slope RT (%) | 1.3 |

Possible Solutions:

**Remove & Replace Curb Ramp With Two New Directional Ramps or Equivalent.**

**R304.3.2, STD 1115**
