# Access Compliance Report Public Rights-of-Way (Curb Ramps)

| Main Street: DANZA_ST | | Cross Street: VIVIDO_ST | | Location: | E |
| ADA ID: RPRK211116134937 | Ramp Type: Type 4 - Parallel | Initial Pass/Fail: Fail | Overall Compliance: No | Severity Score: | 15 |

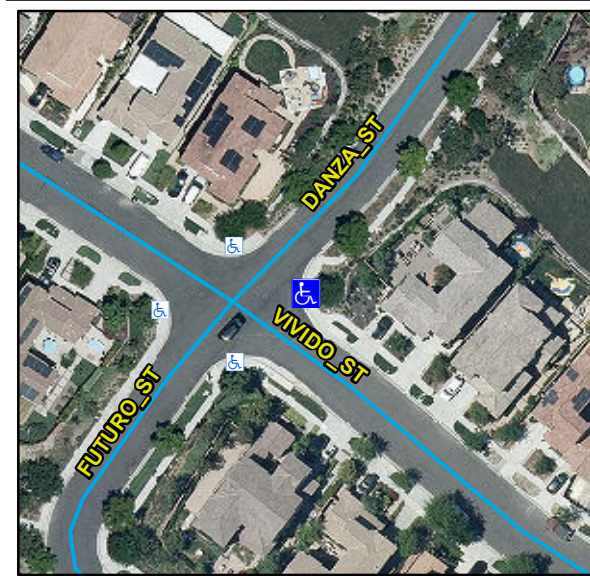
| Compliance | Description | Data | Compliance | Description | Data |
|---|---|---|---|---|---|
| No | Ramp Run Slope LT (%) | 8.9 | Yes | Ramp Run Slope RT (%) | 0.8 |

**Remove & Replace Curb Ramp With Two New Directional Ramps or Equivalent.**

**R304.3.2, STD 1115**

Total Cost: \$ 4000
