# Access Compliance Report Public Rights-of-Way (Curb Ramps)

| Main Street: CORAZON_ST | | Cross Street: DANZA_ST | | Location: | S |
| ADA ID: RPRK211116135208 | Ramp Type: Type 4 - Parallel | Initial Pass/Fail: Pass | Overall Compliance: No | Severity Score: | 5 |

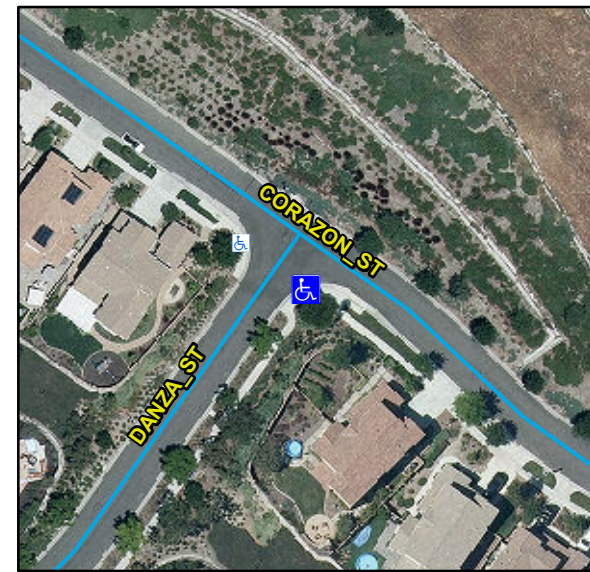
| Compliance | Description | Data | Compliance | Description | Data |
|---|---|---|---|---|---|
| No | Landing Cross Slope (%) | 5.6 | | DWS Offset Type | Single |
| No | Gutter Cross Slope (%) | 5.6 | Yes | Perpendicular Joint Present | Yes |

**Remove & Replace Landing. Remove & Replace Gutter.**

**R304.5.3, STD 1115**

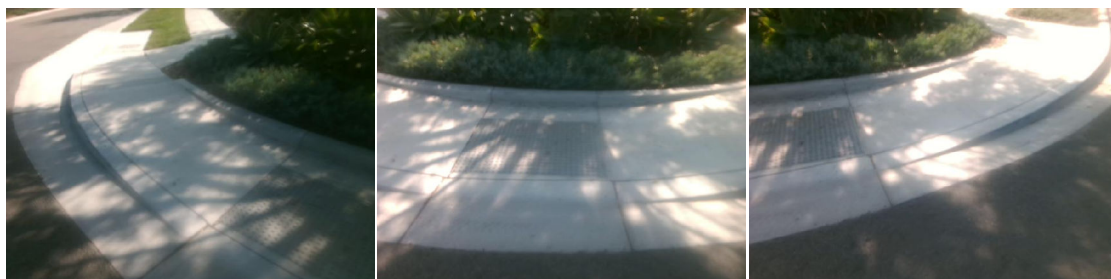
| Compliance | Description | Data | Compliance | Description | Data |
|---|---|---|---|---|---|
| Yes | Ramp Run Slope LT (%) | 7.8 | Yes | Ramp Run Slope RT (%) | 2.3 |
