# Access Compliance Report Public Rights-of-Way (Curb Ramps)

Main Street: DANZA\_ST Cross Street: CORAZON\_ST Location: W

ADA ID: RPRK211116135507 Ramp Type: Type 4 - Parallel Initial Pass/Fail: Pass Overall Compliance: No Severity Score: 0

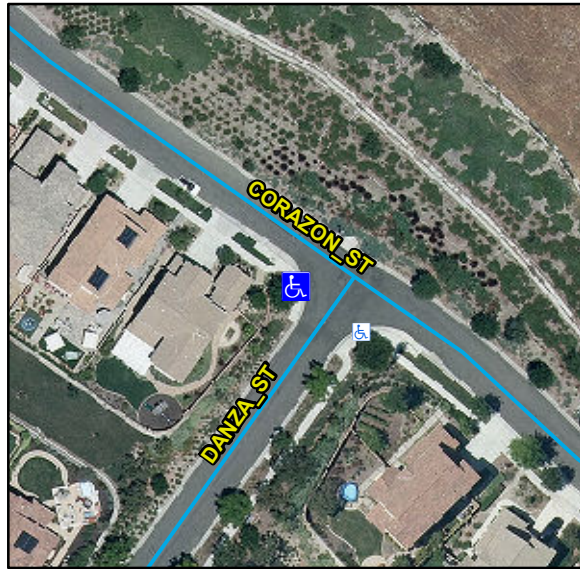
| Compliance | Description | Data | Compliance | Description | Data |
|---|---|---|---|---|---|
| No | Landing Cross Slope (%) | 2.4 | | DWS Offset Type | Single |
| No | Gutter Cross Slope (%) | 2.4 | Yes | Perpendicular Joint Present | Yes |

Remove & Replace Landing. Remove & Replace Gutter.

R304.5.3, STD 1115
