# Access Compliance Report Public Rights-of-Way (Curb Ramps)

| Main Street: VIVIDO_ST | | Cross Street: DANZA_ST | | Location: | N |
| ADA ID: RPRK211116135749 | Ramp Type: Type 4 - Parallel | Initial Pass/Fail: Fail | Overall Compliance: No | Severity Score: | 15 |

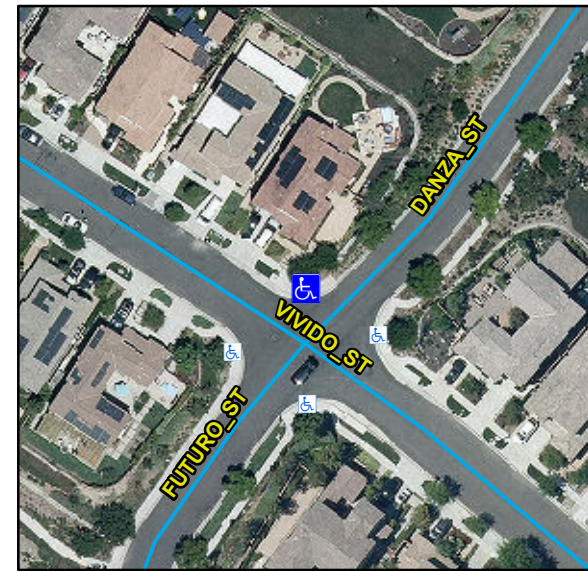
| Compliance | Description | Data | Compliance | Description | Data |
|---|---|---|---|---|---|
| Yes | Ramp Run Slope LT (%) | 2 | No | Ramp Run Slope RT (%) | 10.1 |

**Remove & Replace Curb Ramp With Two New Directional Ramps or Equivalent.**

**R304.3.2, STD 1115**

Total Cost: \$ 4000

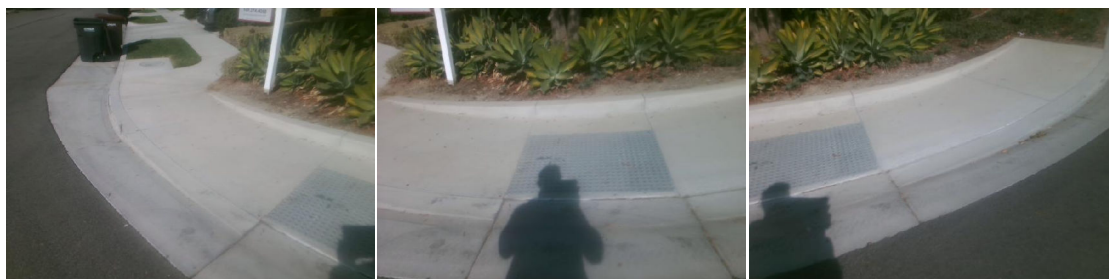
| Compliance | Description | Data | Compliance | Description | Data |
|---|---|---|---|---|---|
| N/A | Ramp Length LT (in) | 74 | N/A | Ramp Length RT (in) | 78 |
| Yes | Ramp Width LT (in) | 54 | Yes | Ramp Width RT (in) | 54 |
| Yes | Ramp Cross Slope LT (%) | 1.3 | Yes | Ramp Cross Slope RT (%) | 1 |
