# Access Compliance Report Public Rights-of-Way (Curb Ramps)

Main Street: SENDERO\_WAY Cross Street: FUTURO\_ST Location: NW

ADA ID: RPRK211116140405 Ramp Type: Type 4 - Parallel Initial Pass/Fail: Fail Overall Compliance: No Severity Score: 32

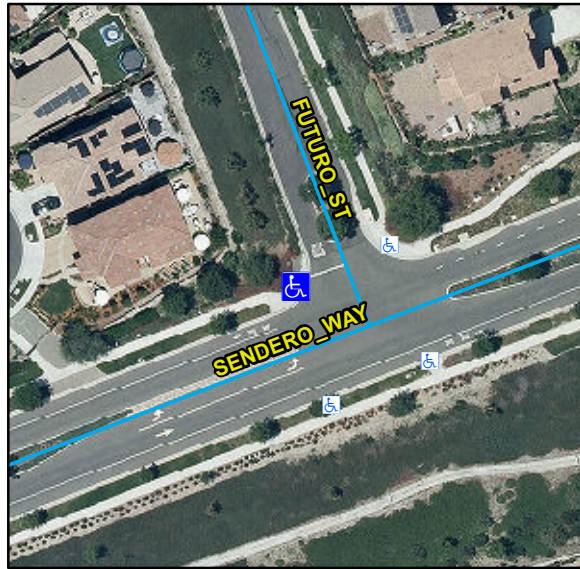
| Compliance | Description | Data | Compliance | Description | Data |
|---|---|---|---|---|---|
| No | Ramp Run Slope LT (%) | 10.8 | No | Ramp Run Slope RT (%) | 17 |
| Yes | Ramp Cross Slope LT (%) | 1.8 | No | Ramp Cross Slope RT (%) | 2.1 |

Remove & Replace Curb Ramp With Two New Directional Ramps or Equivalent.

R304.3.2, R304.5.3, STD 1115
