# Access Compliance Report Public Rights-of-Way (Curb Ramps)

| Main Street: FUTURO_ST | | Cross Street: SENDERO_WAY | | Location: | NE |
| ADA ID: RPRK211116140611 | Ramp Type: Type 4 - Parallel | Initial Pass/Fail: Fail | Overall Compliance: No | Severity Score: | 16 |

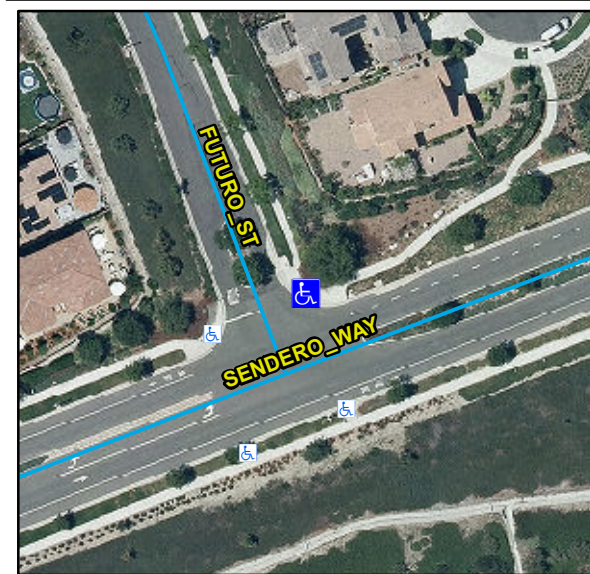
| Compliance | Description | Data | Compliance | Description | Data |
|---|---|---|---|---|---|
| Yes | Ramp Run Slope LT (%) | 8.1 | No | Ramp Run Slope RT (%) | 11.9 |
| No | Ramp Cross Slope LT (%) | 4.4 | No | Ramp Cross Slope RT (%) | 2.3 |

**Remove & Replace Curb Ramp With Two New Directional Ramps or Equivalent.**

**R304.5.3, R304.3.2, STD 1115**

Total Cost: \$ 4000
