# Access Compliance Report Public Rights-of-Way (Curb Ramps)

Main Street: SENDERO\_WAY Cross Street: FUTURO\_ST Location: S

ADA ID: RPRK211116140817 Ramp Type: Type 1 - Perpendicular Initial Pass/Fail: Pass Overall Compliance: No Severity Score: 25

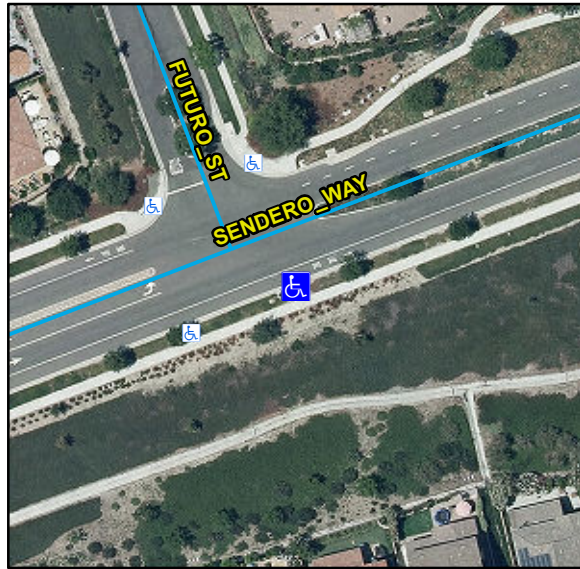
| Compliance | Description | Data | Compliance | Description | Data |
|---|---|---|---|---|---|
| No | Ramp Cross Slope (%) | 7 | N/A | Flare Traversable LT | No |
| No | Landing Cross Slope (%) | 7.3 | Yes | DWS Provided | Yes |
| No | Gutter Run Slope (%) | 13.8 | | Road Cross Slope (%) | N/A |
| No | Gutter Cross Slope (%) | 7.5 | | | |

Remove & Replace Entire Ramp. Remove & Replace Gutter.
