# Access Compliance Report Public Rights-of-Way (Curb Ramps)

Main Street: **RASTRO\_ST** Cross Street: **NACIENTE\_ST** Location: **E**

ADA ID: **RPRK211116141402** Ramp Type: **Type 4 - Parallel** Initial Pass/Fail: **Fail** Overall Compliance: **No** Severity Score: **30**

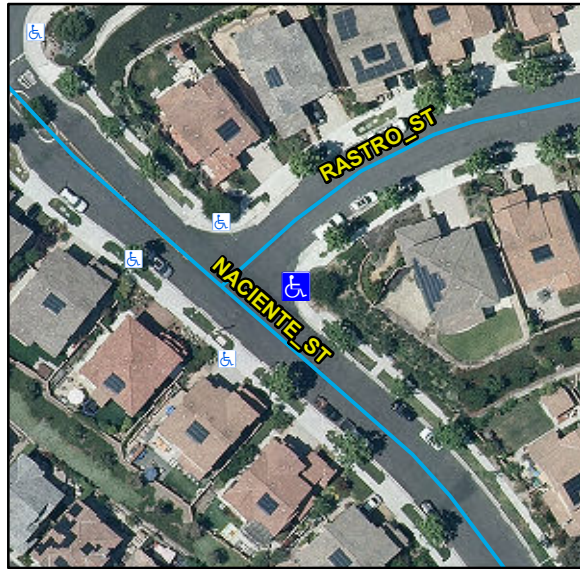
| Compliance | Description | Data | Compliance | Description | Data |
|---|---|---|---|---|---|
| <b>No</b> | Ramp Run Slope LT (%) | <b>12.3</b> | <b>Yes</b> | Ramp Run Slope RT (%) | <b>4.4</b> |

**Remove & Replace Curb Ramp With Two New Directional Ramps or Equivalent.**

**R304.3.2, STD 1115**
