# Access Compliance Report Public Rights-of-Way (Curb Ramps)

Main Street: NACIENTE\_ST Cross Street: RASTRO\_ST Location: N

ADA ID: RPRK211116141608 Ramp Type: Type 4 - Parallel Initial Pass/Fail: Fail Overall Compliance: No Severity Score: 16

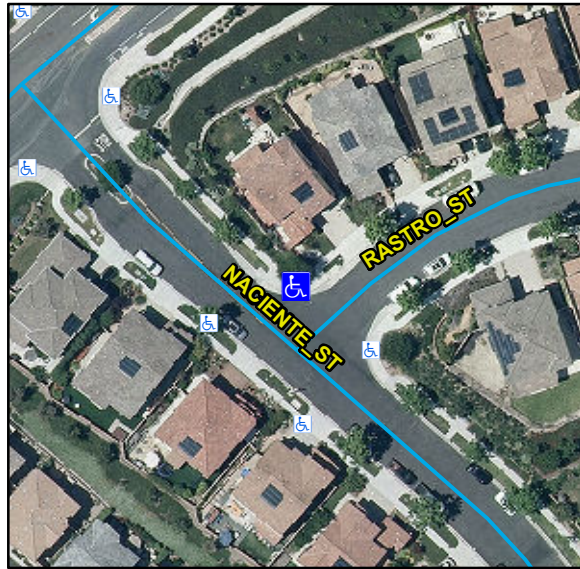
| Compliance | Description | Data | Compliance | Description | Data |
|---|---|---|---|---|---|
| No | Ramp Run Slope LT (%) | 8.9 | Yes | Ramp Run Slope RT (%) | 1.4 |
| No | Ramp Cross Slope LT (%) | 2.7 | Yes | Ramp Cross Slope RT (%) | 0.4 |

**Remove & Replace Curb Ramp With Two New Directional Ramps or Equivalent.**

**R304.3.2, R304.5.3, STD 1115**
