# Access Compliance Report Public Rights-of-Way (Curb Ramps)

Main Street: SENDERO WAY Cross Street: NACIENTE ST Location: SE

ADA ID: RPRK211116141818 Ramp Type: Type 4 - Parallel Initial Pass/Fail: Fail Overall Compliance: No Severity Score: 30

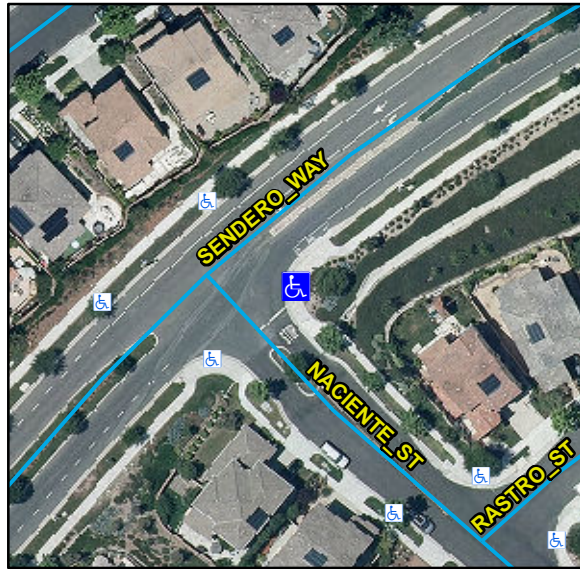
| Compliance | Description | Data | Compliance | Description | Data |
|---|---|---|---|---|---|
| No | Ramp Run Slope LT (%) | 18.6 | No | Ramp Run Slope RT (%) | 9.5 |

**Remove & Replace Curb Ramp With Two New Directional Ramps or Equivalent.**

**R304.3.2, STD 1115**
