# Access Compliance Report Public Rights-of-Way (Curb Ramps)

| Main Street: SENDERO WAY | | Cross Street: NACIENTE ST | | Location: | NE |
| ADA ID: RPRK211117124815 | Ramp Type: Type 1 - Perpendicular | Initial Pass/Fail: Fail | Overall Compliance: No | Severity Score: | 45 |

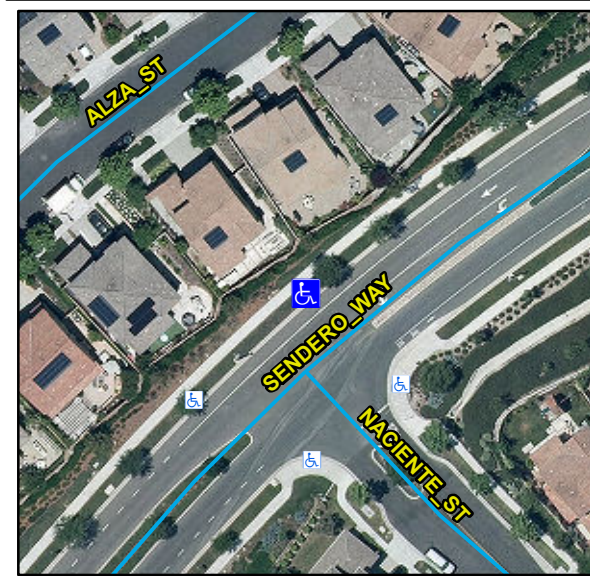
R304.2.2, R304.5.3, STD 1115

| Compliance | Description | Data | Compliance | Description | Data |
|---|---|---|---|---|---|
| No | Ramp Run Slope (%) | 9.2 | N/A | Flare Slope LT (%) | N/A |
| No | Ramp Cross Slope (%) | 8.9 | N/A | Flare Traversable LT | N/A |

Possible Solutions:

Remove & Replace Entire Ramp.

Total Cost: \$ 3080
