# Access Compliance Report Public Rights-of-Way (Curb Ramps)

| Main Street: ALZA_ST | | Cross Street: ASCENSO_AVE | | Location: | SE |

| ADA ID: RPRK211117130851 | Ramp Type: Type 4 - Parallel | Initial Pass/Fail: Fail | Overall Compliance: No | Severity Score: | 15 |

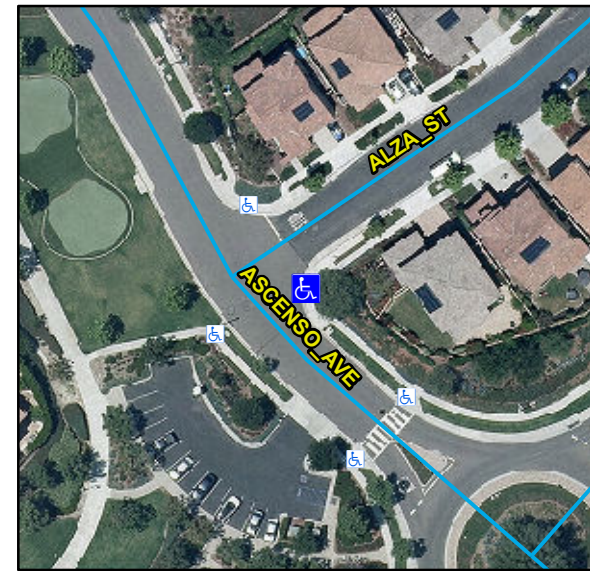
| Compliance | Description | Data | Compliance | Description | Data |
|---|---|---|---|---|---|
| No | Ramp Run Slope LT (%) | 9.4 | Yes | Ramp Run Slope RT (%) | 3 |

**Remove & Replace Curb Ramp With Two New Directional Ramps or Equivalent.**

**R304.3.2, STD 1115**

Total Cost: \$ 4000
