# Access Compliance Report Public Rights-of-Way (Curb Ramps)

Main Street: ASCENSO\_AVE Cross Street: CIELO\_ST Location: NE

ADA ID: RPRK211117132550 Ramp Type: Type 4 - Parallel Initial Pass/Fail: Fail Overall Compliance: No Severity Score: 30

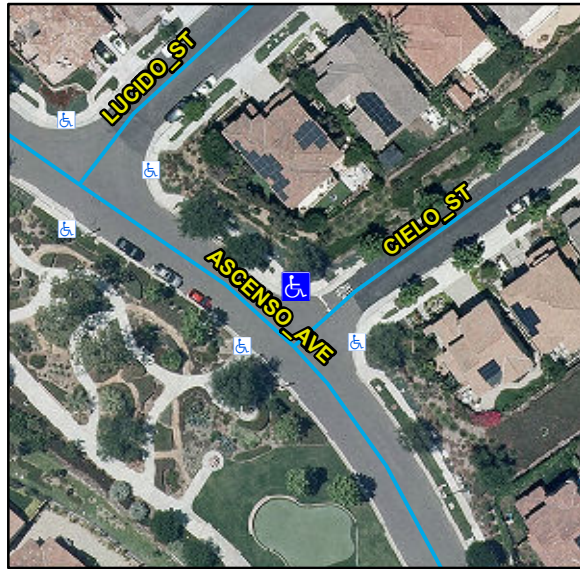
| Compliance | Description | Data | Compliance | Description | Data |
|---|---|---|---|---|---|
| No | Ramp Run Slope LT (%) | 12.7 | Yes | Ramp Run Slope RT (%) | 2.7 |

Remove & Replace Curb Ramp With Two New Directional Ramps or Equivalent.

R304.3.2, STD 1115
