# Access Compliance Report Public Rights-of-Way (Curb Ramps)

| Main Street: ASCENSO_AVE | | Cross Street: LUCIDO_ST | | Location: | N |
| ADA ID: RPRK211117134233 | Ramp Type: Type 4 - Parallel | Initial Pass/Fail: Fail | Overall Compliance: No | Severity Score: | 16 |

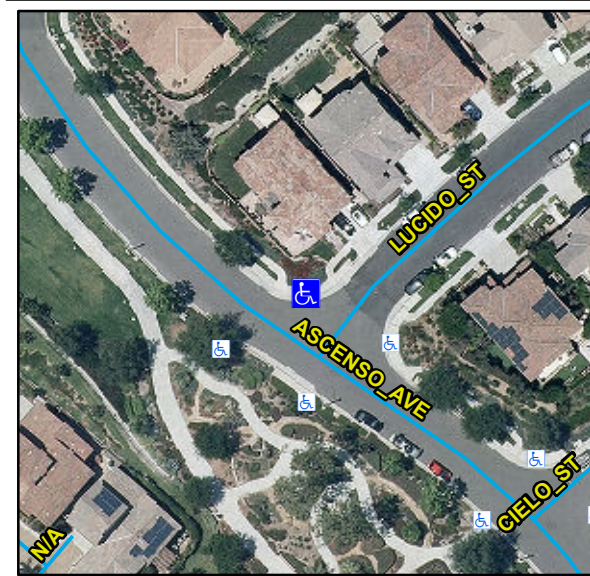
| Compliance | Description | Data | Compliance | Description | Data |
|---|---|---|---|---|---|
| No | Ramp Run Slope LT (%) | 11.5 | Yes | Ramp Run Slope RT (%) | 0.2 |
| Yes | Ramp Cross Slope LT (%) | 0.4 | No | Ramp Cross Slope RT (%) | 3.4 |

**Remove & Replace Curb Ramp With Two New Directional Ramps or Equivalent.**

**R304.3.2, R304.5.3, STD 1115**
