# Access Compliance Report Public Rights-of-Way (Curb Ramps)

Main Street: **AMADO\_PL** Cross Street: **ASCENSO\_AVE** Location: **SE**

ADA ID: **RPRK211117140232** Ramp Type: **Type 4 - Parallel** Initial Pass/Fail: **Fail** Overall Compliance: **No** Severity Score: **16**

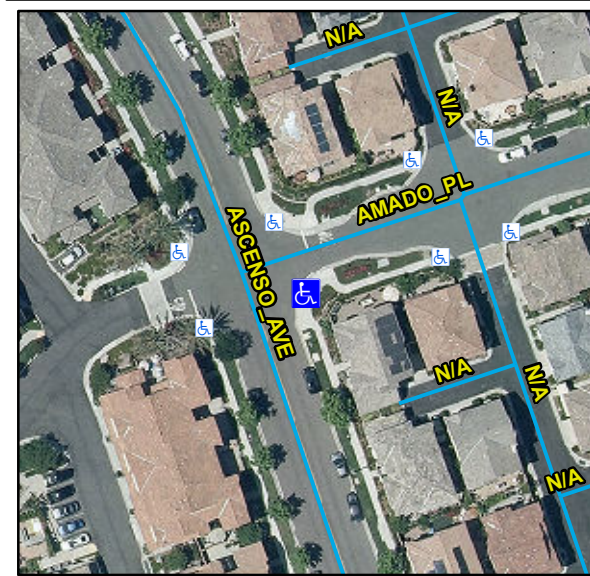
| Compliance | Description | Data | Compliance | Description | Data |
|---|---|---|---|---|---|
| No | Ramp Run Slope LT (%) | 9 | Yes | Ramp Run Slope RT (%) | 6.2 |
| Yes | Ramp Cross Slope LT (%) | 1.2 | No | Ramp Cross Slope RT (%) | 2.1 |

Possible Solutions:  
**Remove & Replace Curb Ramp With Two New Directional Ramps or Equivalent.**

OC Std/PROW:  
**R304.3.2, R304.5.3, STD 1115**

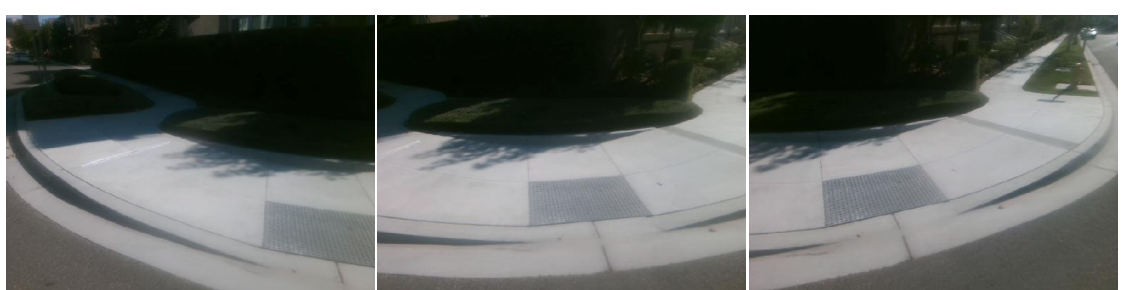
| Compliance | Description | Data | Compliance | Description | Data |
|---|---|---|---|---|---|
| N/A | Ramp Length LT (in) | 100 | N/A | Ramp Length RT (in) | 73 |
| Yes | Ramp Width LT (in) | 89 | Yes | Ramp Width RT (in) | 89 |
