# Access Compliance Report Public Rights-of-Way (Curb Ramps)

Main Street: BRIOSO\_ST Cross Street: ASCENSO\_AVE Location: NW

ADA ID: RPRK211117153816 Ramp Type: Type 4 - Parallel Initial Pass/Fail: Fail Overall Compliance: No Severity Score: 16

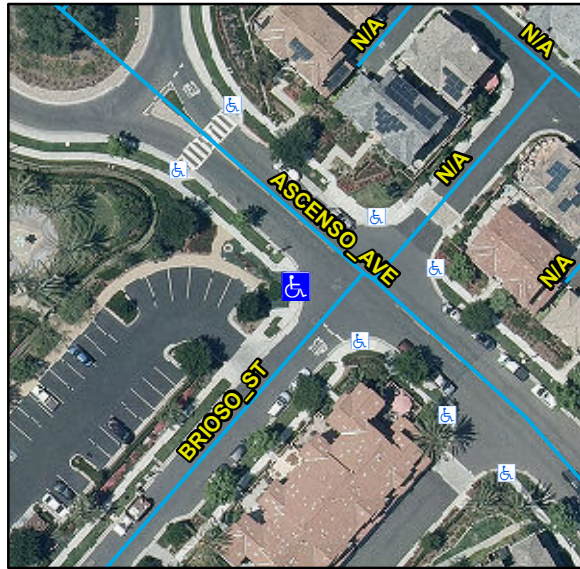
| Compliance | Description | Data | Compliance | Description | Data |
|---|---|---|---|---|---|
| Yes | Ramp Run Slope LT (%) | 3.4 | No | Ramp Run Slope RT (%) | 8.7 |
| No | Ramp Cross Slope LT (%) | 2.5 | No | Ramp Cross Slope RT (%) | 2.3 |

Remove & Replace Curb Ramp With Two New Directional Ramps or Equivalent.

R304.5.3, R304.3.2, STD 1115
