# Access Compliance Report Public Rights-of-Way (Curb Ramps)

| Main Street: ASCENSO_AVE | | Cross Street: N/A | | Location: | NE |
| ADA ID: RPRK211117154529 | Ramp Type: Type 4 - Parallel | Initial Pass/Fail: Pass | Overall Compliance: No | Severity Score: | 6 |

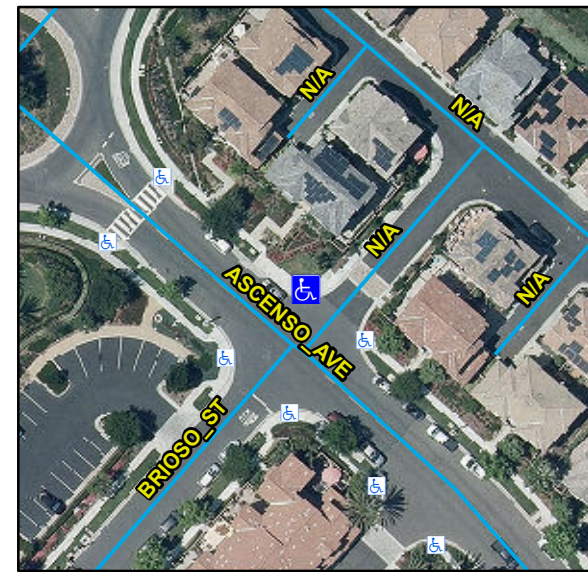
| Compliance | Description | Data | Compliance | Description | Data |
|---|---|---|---|---|---|
| No | Landing Run Slope (%) | 2.3 | Yes | DWS Full Width | Yes |
| No | Gutter Run Slope (%) | 7.6 | | Road Cross Slope (%) | 4.1 |

**Remove & Replace Landing. Remove & Replace Gutter.**

**R304.2.2-Perp, R304.3.2-Para, R304.5.4, STD 1115**

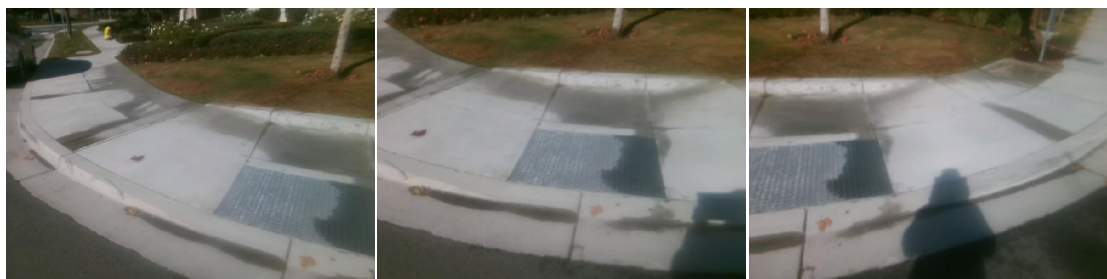
| Compliance | Description | Data | Compliance | Description | Data |
|---|---|---|---|---|---|
| Yes | Ramp Run Slope LT (%) | 6.5 | Yes | Ramp Run Slope RT (%) | 7.4 |
| Yes | Ramp Cross Slope LT (%) | 1.6 | Yes | Ramp Cross Slope RT (%) | 0.2 |
