# Access Compliance Report Public Rights-of-Way (Curb Ramps)

Main Street: CONTIGO\_PL Cross Street: AMADO\_PL Location: SW

ADA ID: RPRK211117161315 Ramp Type: Type 4 - Parallel Initial Pass/Fail: Pass Overall Compliance: No Severity Score: 5

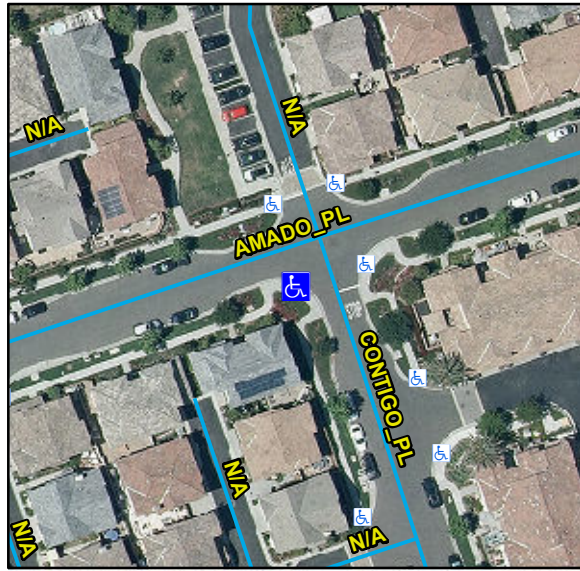
| Compliance | Description | Data | Compliance | Description | Data |
|---|---|---|---|---|---|
| No | Gutter Run Slope (%) | 10.1 | | Road Cross Slope (%) | 1 |

Remove & Replace Gutter.

R304.5.4, STD 1115
