# Access Compliance Report Public Rights-of-Way (Curb Ramps)

Main Street: AMADO\_PL Cross Street: CONTIGO\_PL Location: SE

ADA ID: RPRK211117161523 Ramp Type: Type 4 - Parallel Initial Pass/Fail: Pass Overall Compliance: No Severity Score: 6

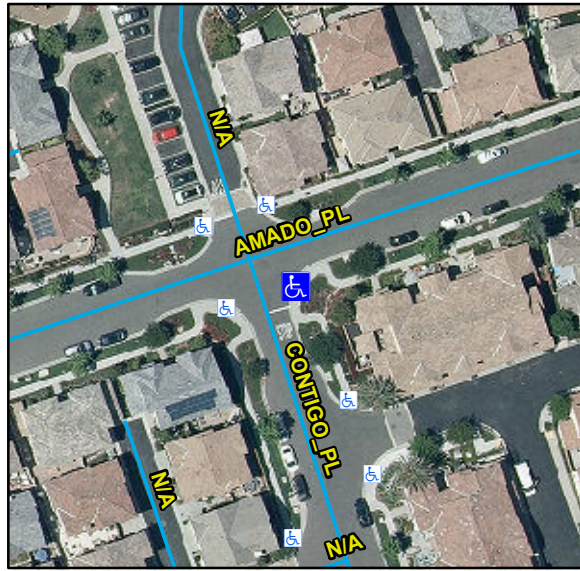
| Compliance | Description | Data | Compliance | Description | Data |
|---|---|---|---|---|---|
| No | Landing Cross Slope (%) | 2.8 | | DWS Offset Type | Single |
| No | Gutter Run Slope (%) | 9.6 | | Road Cross Slope (%) | 2.6 |
| No | Gutter Cross Slope (%) | 2.8 | Yes | Perpendicular Joint Present | Yes |

Remove & Replace Landing. Remove & Replace Gutter.

R304.5.3, R304.5.4, STD 1115
