# Access Compliance Report Public Rights-of-Way (Curb Ramps)

Main Street: CONTIGO\_PL Cross Street: RIBERA\_RD Location: NE

ADA ID: RPRK211117163723 Ramp Type: Type 4 - Parallel Initial Pass/Fail: Pass Overall Compliance: No Severity Score: 5

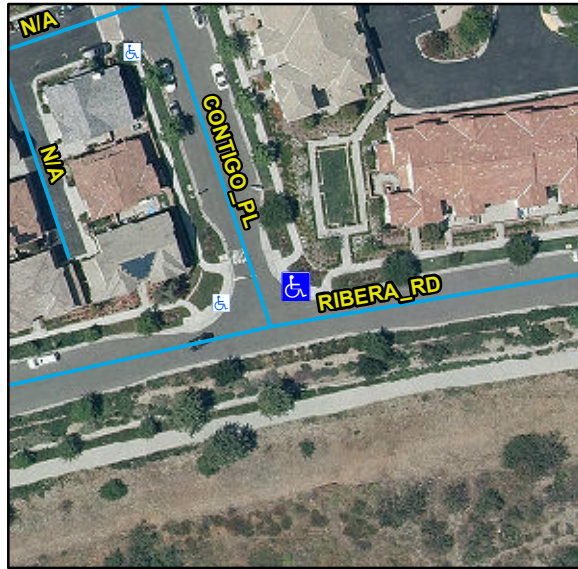
| Compliance | Description | Data | Compliance | Description | Data |
|---|---|---|---|---|---|
| No | Gutter Run Slope (%) | 8 | | Road Cross Slope (%) | 1.6 |

Remove & Replace Gutter.

R304.5.4, STD 1115
