# Access Compliance Report Public Rights-of-Way (Curb Ramps)

Main Street: RIBERA\_RD Cross Street: CONTIGO\_PL Location: NW

ADA ID: RPRK211117163932 Ramp Type: Type 4 - Parallel Initial Pass/Fail: Pass Overall Compliance: No Severity Score: 5

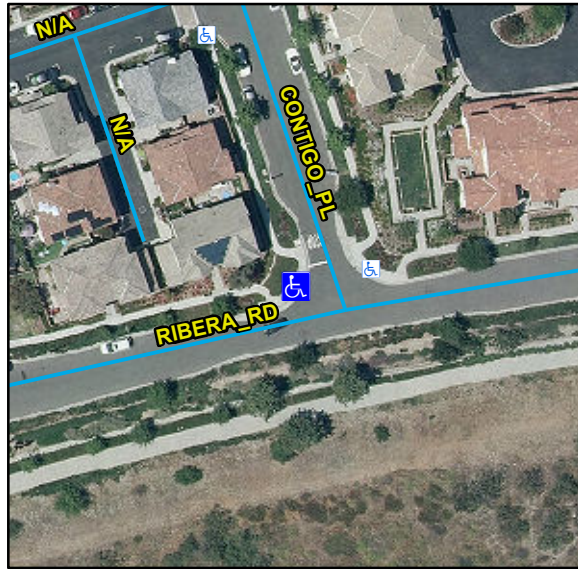
| Compliance | Description | Data | Compliance | Description | Data |
|---|---|---|---|---|---|
| Yes | Gutter Ponding | No | No | Curb Slope | 8.7 |
| No | Gutter Run Slope (%) | 6 | | Road Cross Slope (%) | 1.1 |

Remove & Replace Curb Slope. Remove & Replace Gutter.

R304.2.2, R304.5.4, STD 1115

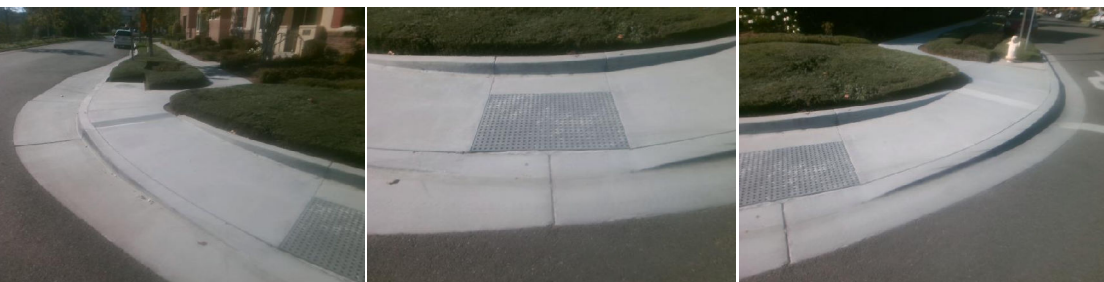
| Compliance | Description | Data | Compliance | Description | Data |
|---|---|---|---|---|---|
| Yes | Overall Surface Condition | Acceptable | | | |
