# Access Compliance Report Public Rights-of-Way (Curb Ramps)

Main Street: CONTIGO\_PL Cross Street: CONTIGO\_PL Location: SE

ADA ID: RPRK211117164912 Ramp Type: Type 4 - Parallel Initial Pass/Fail: Fail Overall Compliance: No Severity Score: 2

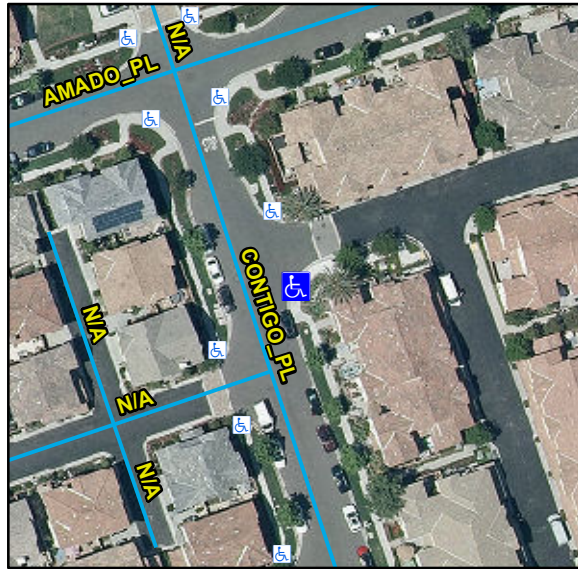
| Compliance | Description | Data | Compliance | Description | Data |
|---|---|---|---|---|---|
| No | Ramp Cross Slope LT (%) | 2.9 | No | Ramp Cross Slope RT (%) | 2.9 |

**Remove & Replace Curb Ramp With Two New Directional Ramps or Equivalent.**

**R304.5.3, STD 1115**

Total Cost: \$ 4000
