# Access Compliance Report Public Rights-of-Way (Curb Ramps)

Main Street: ASCENSO\_AVE Cross Street: RIBERA\_RD Location: NE

ADA ID: RPRK211117165722 Ramp Type: Type 1 - Perpendicular Initial Pass/Fail: Pass Overall Compliance: No Severity Score: 5

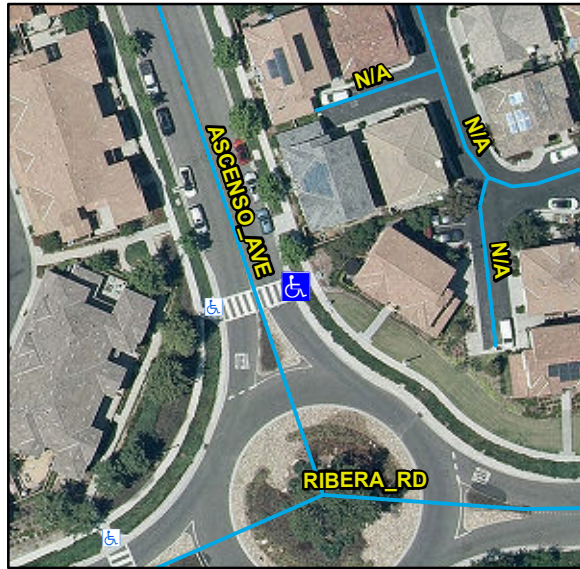
| Compliance | Description | Data | Compliance | Description | Data |
|---|---|---|---|---|---|
| No | Gutter Run Slope (%) | 5.5 | | Road Cross Slope (%) | N/A |
| No | Gutter Cross Slope (%) | 2.2 | | | |

Remove & Replace Gutter.

R304.5.4, R304.5.3, STD 1115
