# Access Compliance Report Public Rights-of-Way (Curb Ramps)

| Main Street: ASCENSO_AVE | | Cross Street: RIBERA_RD | | Location: | NW |
| ADA ID: RPRK211117165948 | Ramp Type:Type 1 - Perpendicular | Initial Pass/Fail: Fail | Overall Compliance: No | Severity Score: | 15 |

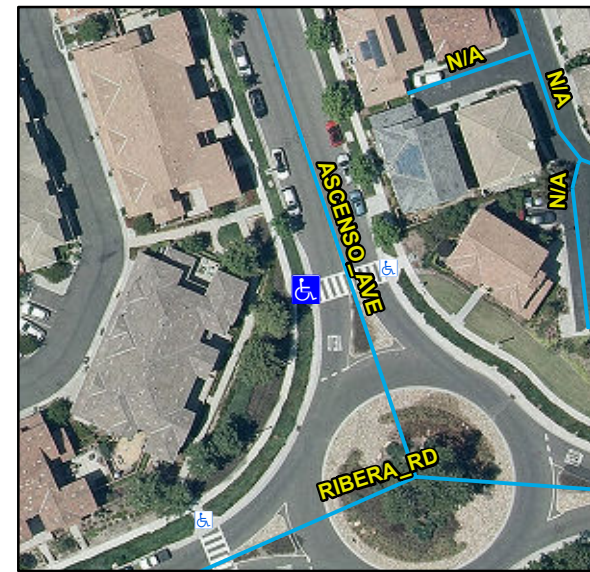
| Compliance | Description | Data | Compliance | Description | Data |
|---|---|---|---|---|---|
| No | Ramp Run Slope (%) | 10.3 | N/A | Flare Slope LT (%) | N/A |
| N/A | Gutter Ponding | N/A | No | Curb Slope | 7.5 |

Remove & Replace Entire Ramp.

R304.2.2, STD 1115

Total Cost: \$ 3080
