# Access Compliance Report Public Rights-of-Way (Curb Ramps)

Main Street: RIBERA\_RD Cross Street: ASCENSO\_AVE Location: W

ADA ID: RPRK211117170048 Ramp Type: Type 1 - Perpendicular Initial Pass/Fail: Pass Overall Compliance: No Severity Score: 5

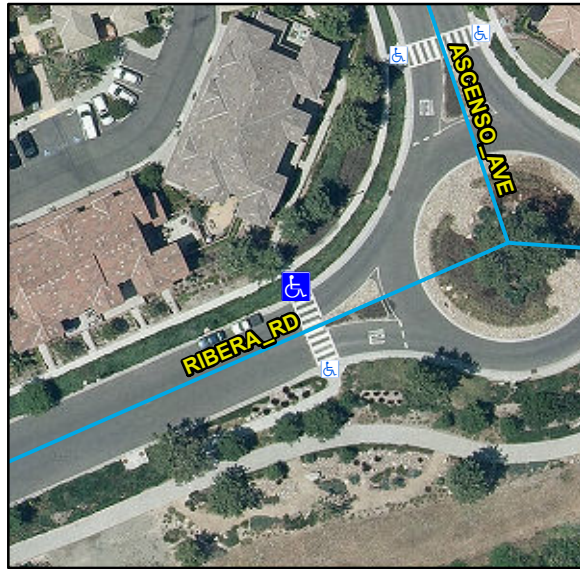
| Compliance | Description | Data | Compliance | Description | Data |
|---|---|---|---|---|---|
| No | Gutter Ponding | Yes | Yes | Curb Slope | 4.1 |
| No | Gutter Run Slope (%) | 5.7 | | Road Cross Slope (%) | N/A |

Remove & Replace Gutter.

R302.7, R304.5.4, STD 1115
